Sep 17th, 2025

1013 Caymus ct, Columbia, MO, 65201

# Home Inspection Report

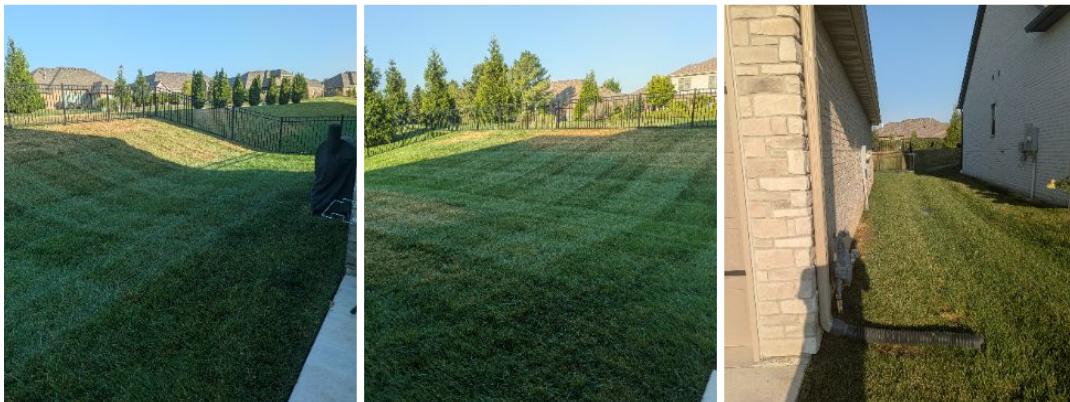
**INFORMATION:** There was some moderate sloping noted at the property. All slopes seem to take the water away from the foundation but has caused some ponding in the yard itself. This condition could cause unwanted pest to thrive. I would recommend some maintenance to fill in these areas to cause the water completely move off of property.

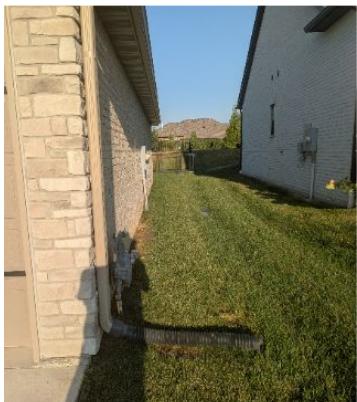
Maintenance

Evidence of poor drainage

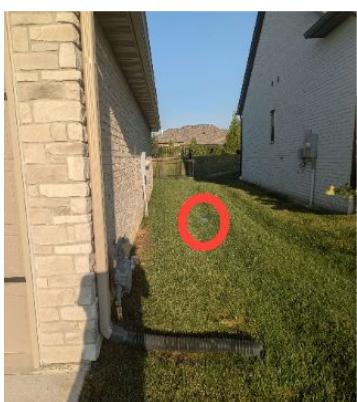
Location - North of garage

Maintenance

Water pooling

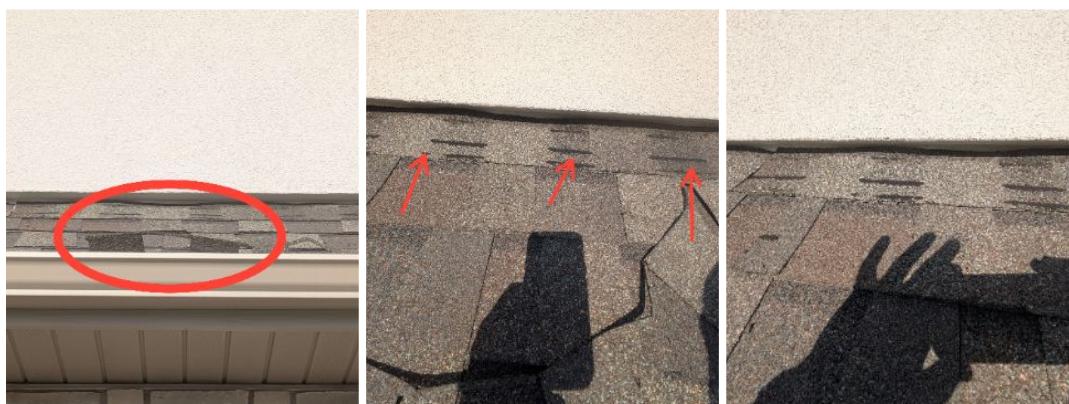
Location - Garage

The roof was walked as much as we could safely do so. There was an area where we found some loose shingles, and they are noted, and this should be fixed as soon as possible.

Requires Attention

Loose or damaged shingle(s). I would recommend a qualified roofing contractor fix. I would recommend this being done as soon as possible.

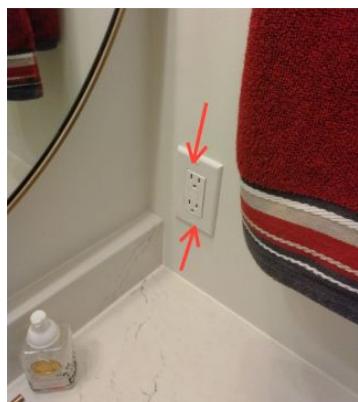
Location - 2nd Floor

Replace faulty GFCI outlet Recommend a qualified electrician to replace GFCI

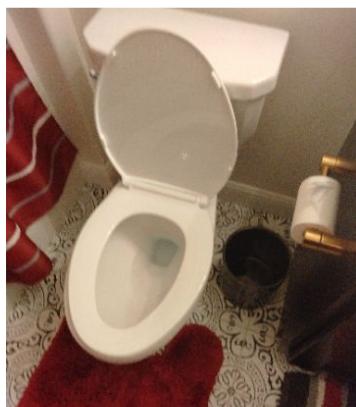
Location - 2nd Floor

Requires Attention

Toilet is loose from the floor. Recommend securing to prevent leaking/water damage.

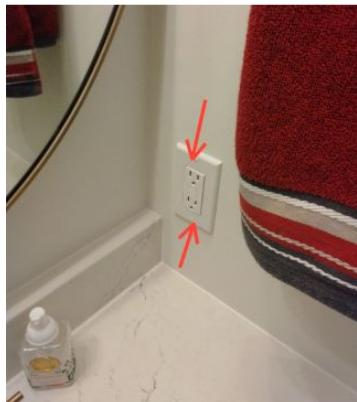
Location - 2nd Floor

Replace faulty GFCI outlet Recommend a qualified electrician to replace GFCI

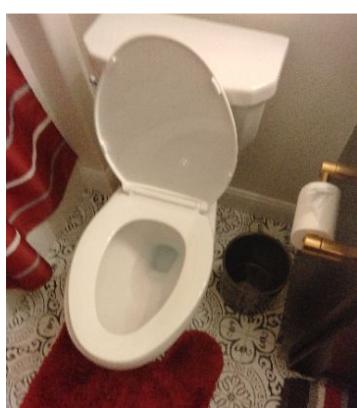
Location - 2nd Floor

Requires Attention

Toilet is loose from the floor. Recommend securing to prevent leaking/water damage.

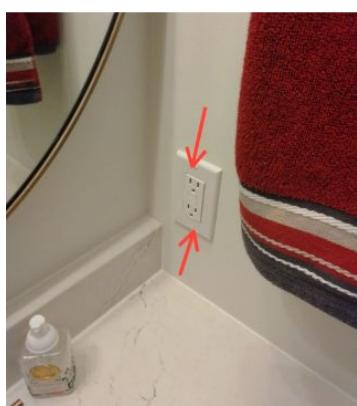
Location - 2nd Floor

Replace faulty GFCI outlet Recommend a qualified electrician to replace GFCI

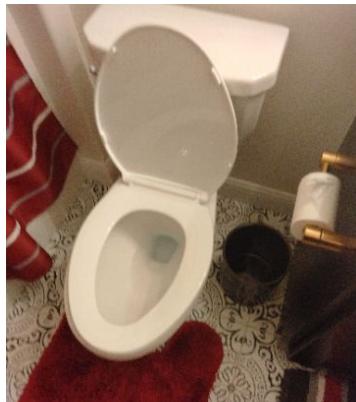
Location - 2nd Floor

Requires Attention

Toilet is loose from the floor. Recommend securing to prevent leaking/water damage.

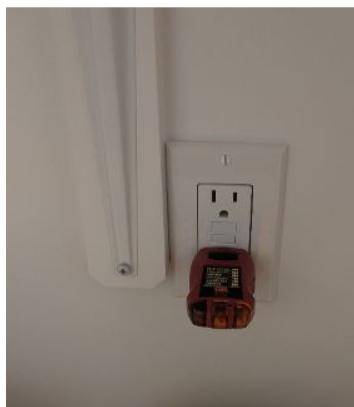
Location - Kitchen

Replace faulty GFCI outlet Recommend having a qualified Electrical contractor replace the GFCI.

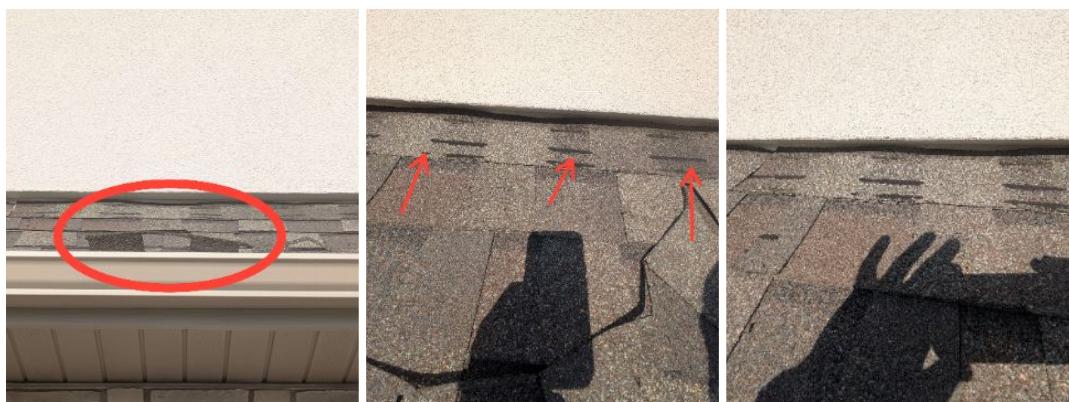
Location - Garage

Loose or damaged shingle(s). I would recommend a qualified roofing contractor fix. I would recommend this being done as soon as possible.

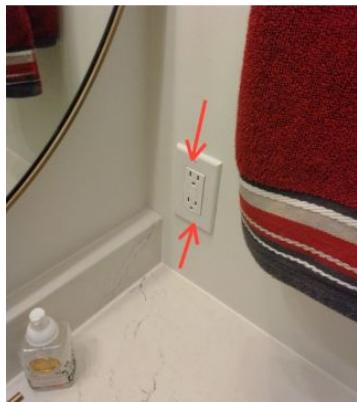
Location - 2nd Floor

Replace faulty GFCI outlet Recommend a qualified electrician to replace GFCI

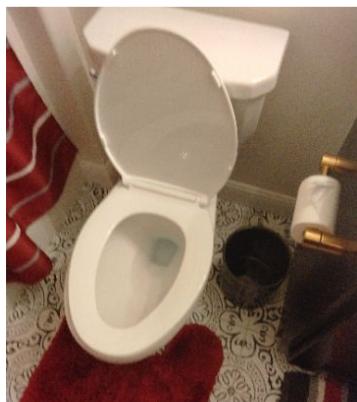
Location - 2nd Floor

Toilet is loose from the floor. Recommend securing to prevent leaking/water damage.

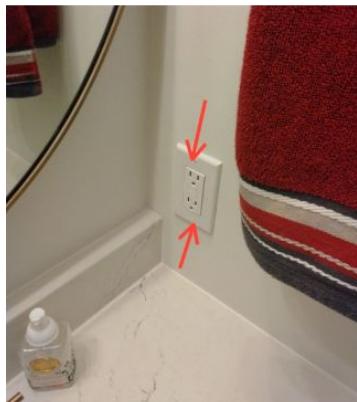
Location - 2nd Floor

Replace faulty GFCI outlet Recommend a qualified electrician to replace GFCI

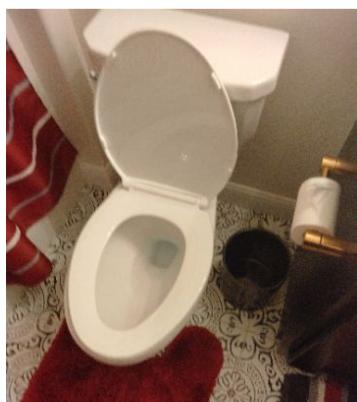
Location - 2nd Floor

Toilet is loose from the floor. Recommend securing to prevent leaking/water damage.

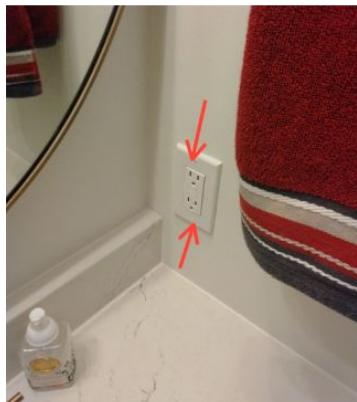
Location - 2nd Floor

Replace faulty GFCI outlet Recommend a qualified electrician to replace GFCI

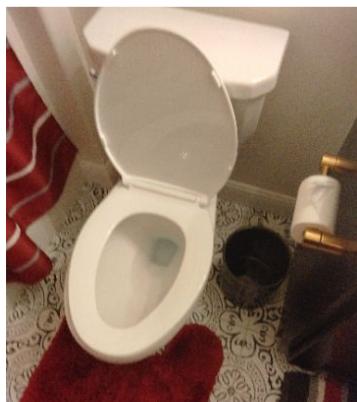
Location - 2nd Floor

Toilet is loose from the floor. Recommend securing to prevent leaking/water damage.

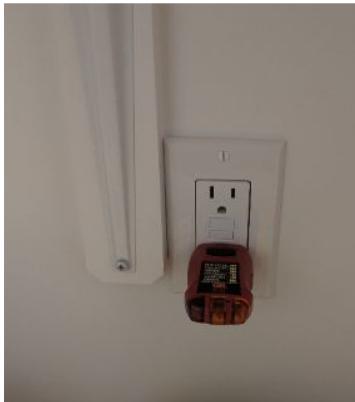
Location - Kitchen

Replace faulty GFCI outlet Recommend having a qualified Electrical contractor replace the GFCI.
