Sep 17th, 2025

1013 Caymus ct, Columbia, MO, 65201

# Home Inspection Report

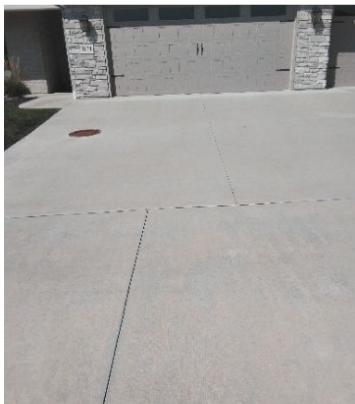
**INFORMATION:** The driveway looks to be in satisfactory shape; no defects were visual. This inspection is limited to above ground situations.

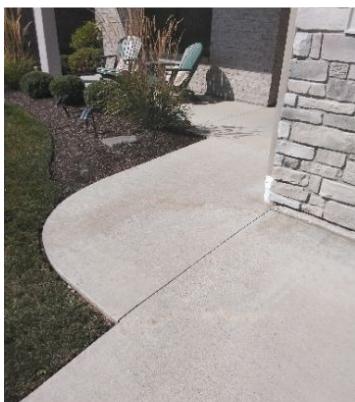
## 1.2 WALKS

**INFORMATION:** The sidewalks were inspected, and no major defects were visualized. The inspection was limited to above ground conditions.

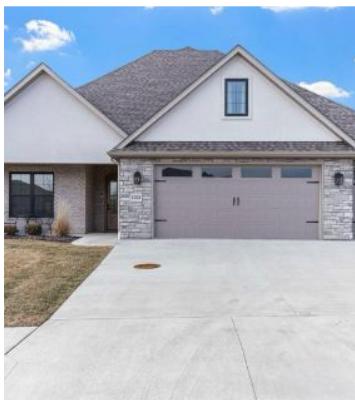
The exterior was a combination of brick, stone and stucco. We didn't notice any defects on the exterior surface of this house.

**DESCRIPTION:** Stucco, Brick

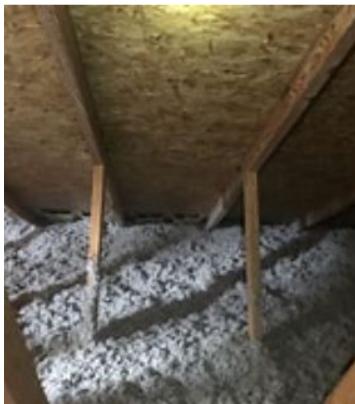
**ATTIC ACCESS:** Hatch access in the West wall of 2nd floor storage area

We were able to inspect the attic by getting into attic. The insulation seemed to be undisturbed and in good shape.
